# Artefakter vid ultraljudsbaserad avbildning

Mattias Mårtensson

1. Teori om artefakter
2. Genomgång av viktigaste bildartefakterna
3. Genomgång av flödesartefakter
4. Resultat från egen forskning om utrustningsfel
  - Inte med på tentan
  - Men är förhoppningsvis av intresse ändå

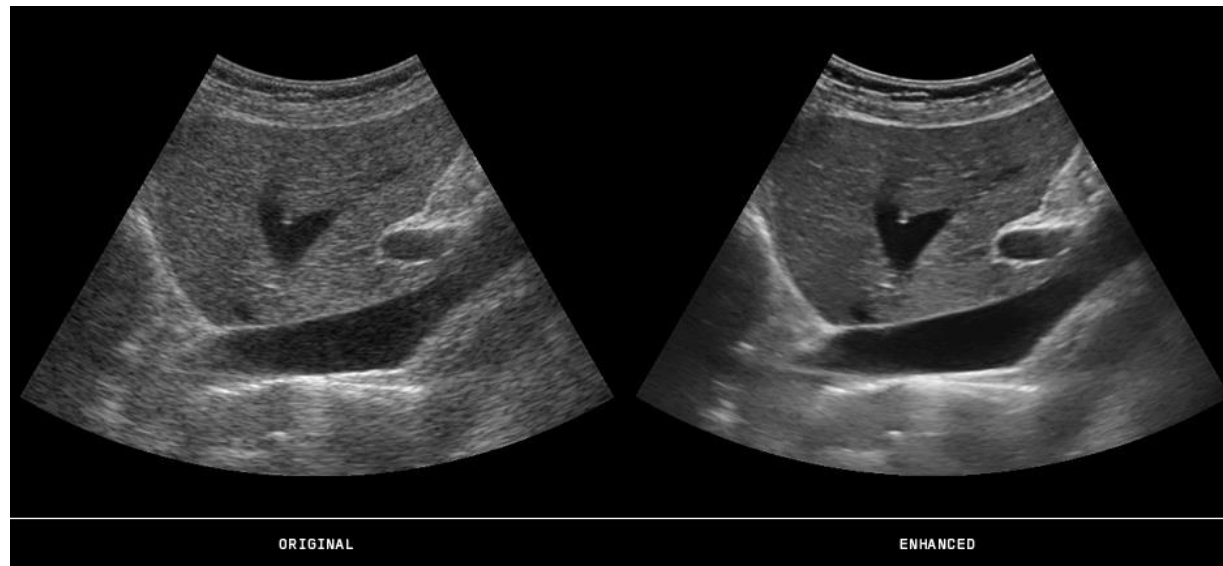
## Speckle pattern

(Gråskalemönstret i bilden)

- Ultraljudsbilder har en "kornighet" som inte är direkt kopplad till reflektorer i vävnaden
  - Är ett mönster som uppstår genom interferens
    - Mönstrets "korn" representerar alltså inte ekon från verkliga ekokällor
  - Många tillverkare har utjämningsalgoritmer

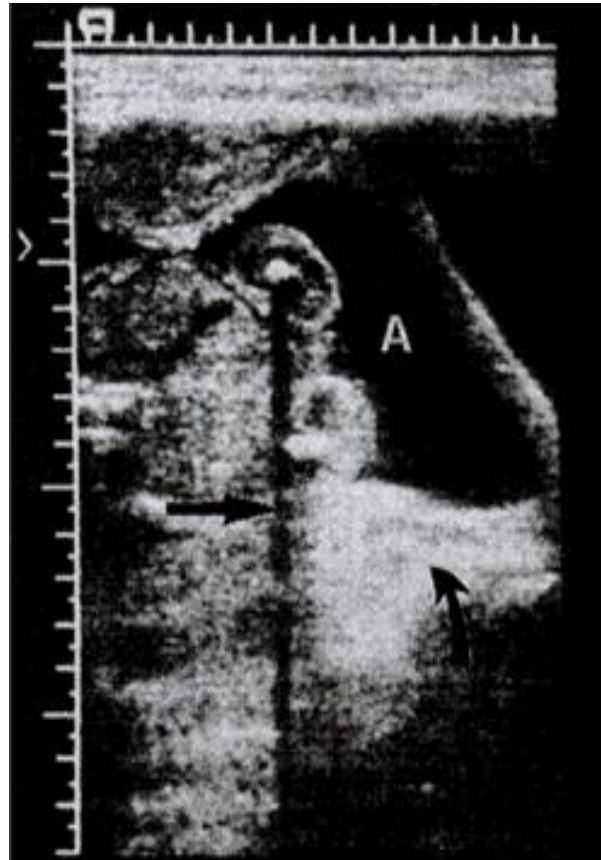
## Shadowing and Enhancement

(Skuggningsartefakt och Förstärkningsartefakt)

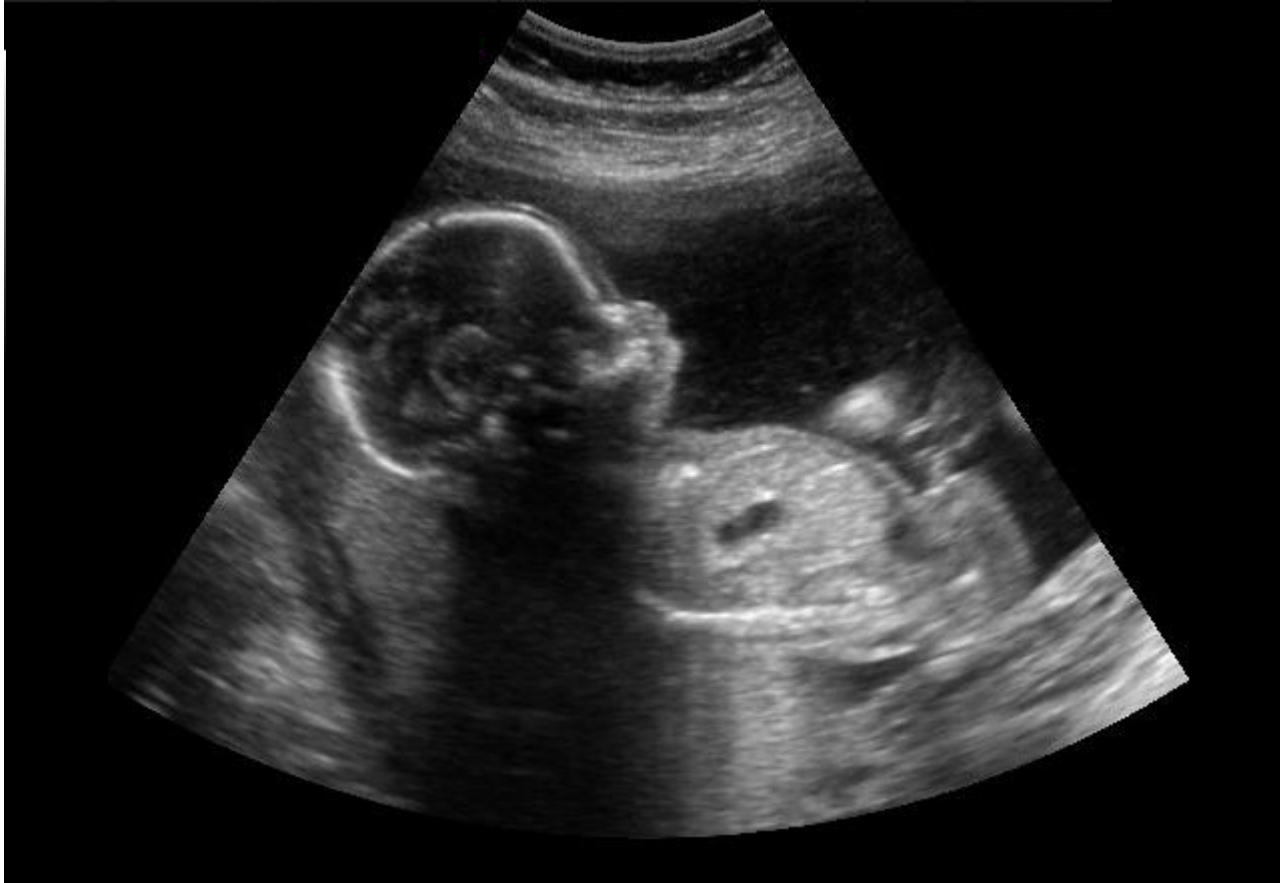
## Shadowing and Enhancement

(Skuggningsartefakt och Förstärkningsartefakt)
